Re: McLain Street Traffic Calming and Accident Reduction  
Town of Bedford, New York

Project:  
**McLain Street Traffic Calming**  
 Town of Bedford, NY

Title:  
**Collision Diagram**  
**McLain Street and**  
**S. Bedford Road (Rt 172)**

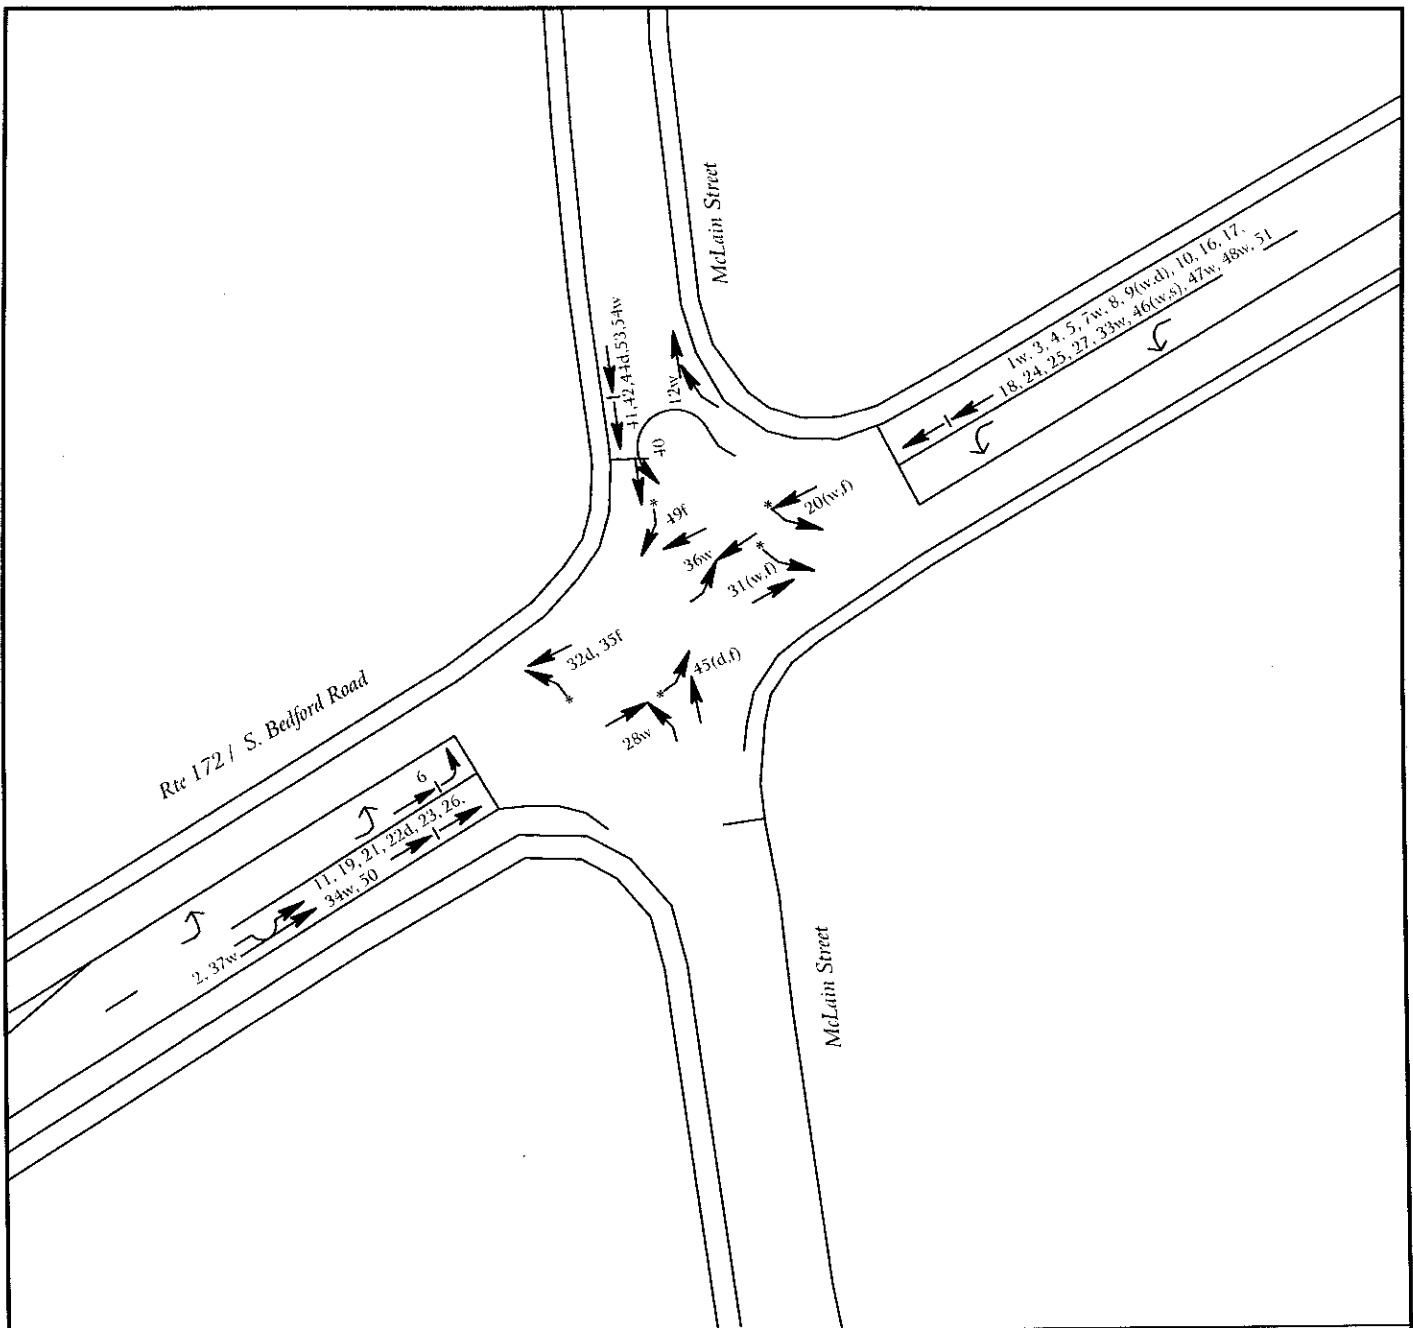
**Figure 1**

A review of the individual accident reports at the intersection of McLain Street with NY Route 172 is presented in Figure 1. There were no fatalities reported along the McLain Street corridor during the study period . Of the 45 intersection-related incidents at the signalized intersection of South Bedford Road and McLain Street, 33 were rear-end related and occurred mostly along the South Bedford Road as can be seen in the Figure 1. There were a total of seven (7) left-turn related incidents at this intersection and all of them involved vehicles either entering or exiting McLain Street. Frequently, rear-end incidents and left-turn incidents are related to insufficient signal clearance time at an intersection. The 12-inch signal lens provided at this intersection are clearly visible to a distance of 250 feet in all the directions. The signage provided is also adequate. Since there were a total of 15 wet-weather related incidents, predominantly in westbound direction, it is recommended that the State be requested to repair westbound approach with skid resistant pavement. It is also recommended that the signal clearance intervals be checked by the New York State Department of Transportation.
